Field Studies: Hardy Road Landfill and Industrial Excess Landfill, A Superfund Site¹

JIM L. JACKSON, JAMES R. BAUDER, JAMES HARDY, AND MARK S. KENNEDY, Center for Environmental Studies, The University of Akron, Akron, OH 44325, James Bauder Inc., 3095 Bernewood Dr., NW, Canton, OH 44709, Chemistry Department and Department of Civil Engineering, The University of Akron, Akron, OH 44325

OHIO J. SCI. 89 (3): 45-55, 1989

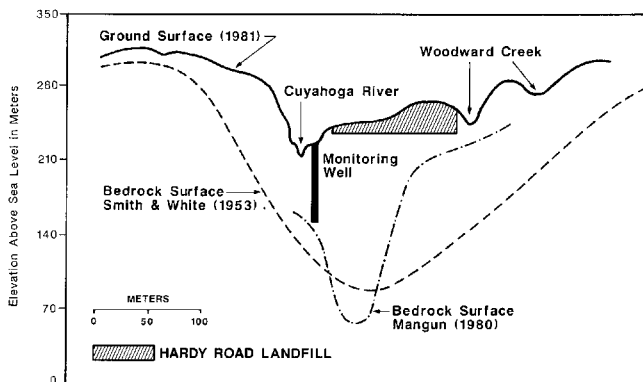
FIGURE 2. Cross-section of Cuyahoga River valley from southwest to northeast beneath the Hardy Road Landfill.

Hardy Road Landfill is on the east side of a buried valley (Fig. 2) (Smith and White 1953, Mangum 1980). Depth to bedrock exceeds 45 m at the northeast corner of the site and exceeds 150 m near the middle to the western boundary of the landfill. None of the ground water and gas monitor wells (Fig. 3) reached bedrock. Depths of the ground water monitor wells are: 1-52 m, 2-60 m, 3-26 m, 4-64 m. Gas monitor wells were developed to a depth of 23 meters. Gas monitor

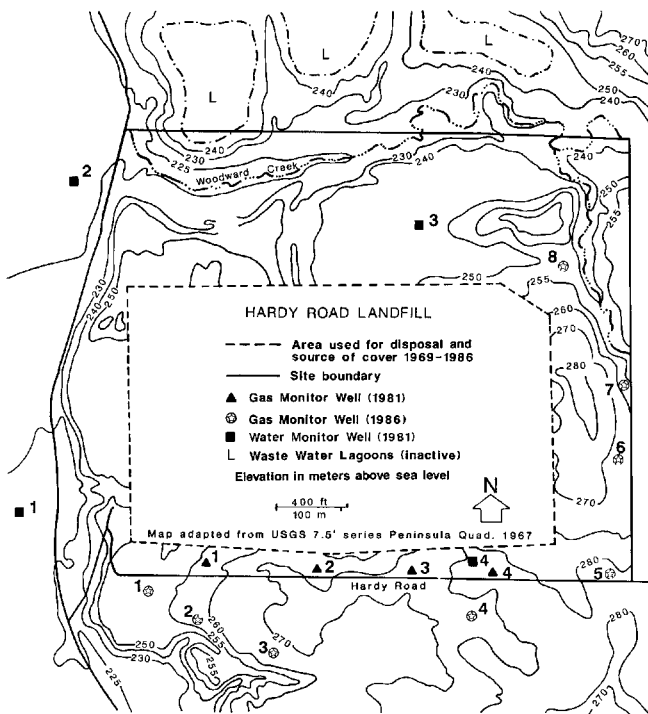
FIGURE 3. Topography and monitor well locations of the Hardy Road Landfill.

Outwash terrace described by White (1982) was used for sewage sludge lagoons shown on the north side of the landfill (Fig. 3). The lagoons are no longer used for disposal of sewage. Outwash can be seen in a recent excavation 70 m west of gas monitor well 1 (Fig. 3). Numerous large erratics, hummocky topography and till indicate the land to the south and east of the site is end moraine. Split-spoon samples from water monitor wells suggest the lacustrine silts and clays are continuous beneath the site.

Water monitor well 1 (Fig. 3), drilled near the southwest corner of the site, penetrated 50 m of silts and a few feet of compact till before reaching gravelly sand. Water overflowed the well casing at about $4.4 \times 10^{-4} \text{ m}^3$ per sec.

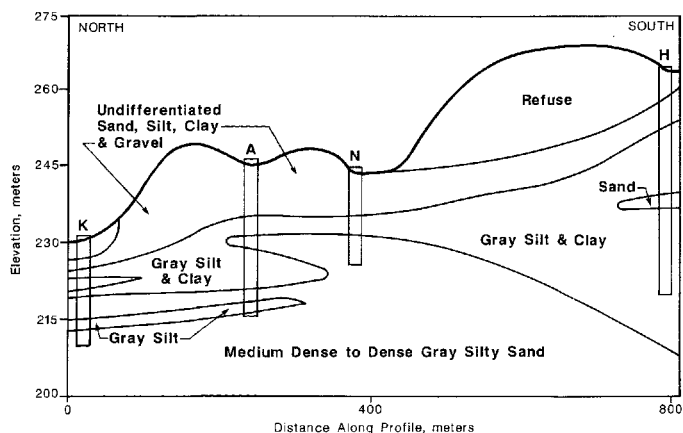
FIGURE 4. North to south cross-section of subsurface deposits beneath the Hardy Road Landfill.

Soils developed on the site and their parent material are described by Ritchie and Steiger (1974). Under current guidelines of the Ohio EPA, the site could not be approved as a landfill if only the soils are considered because the upper several feet of the soil is too permeable. However, surface water infiltration is reduced by using stockpiled till and lacustrine deposits for final cover material. The subsurface conditions of the site are ideal for a sanitary landfill. There are no water wells which penetrate aquifers that are likely to be contaminated within a kilometer of the site. Shale bedrock below the landfill is not a good source of water in Northampton Township and most of northern Summit County. Hydrostatic pressure and low permeability of the lacustrine deposits and shale at depth will prevent bedrock aquifers from being damaged by leachate. Water samples obtained from water monitoring wells installed in 1981, as well as extensive drilling of ground water monitor wells and water analyses completed from 1986 to 1988 under a grant from the Ohio Water Development Authority and the City of Akron, have not detected leachate. Computer projections suggest chlorides will appear in the northwest area of the site in about 20 years (Kennedy and Jackson 1988). Contamination will be limited to shallow undifferentiated sand, silt, clay and gravel (Fig. 4).

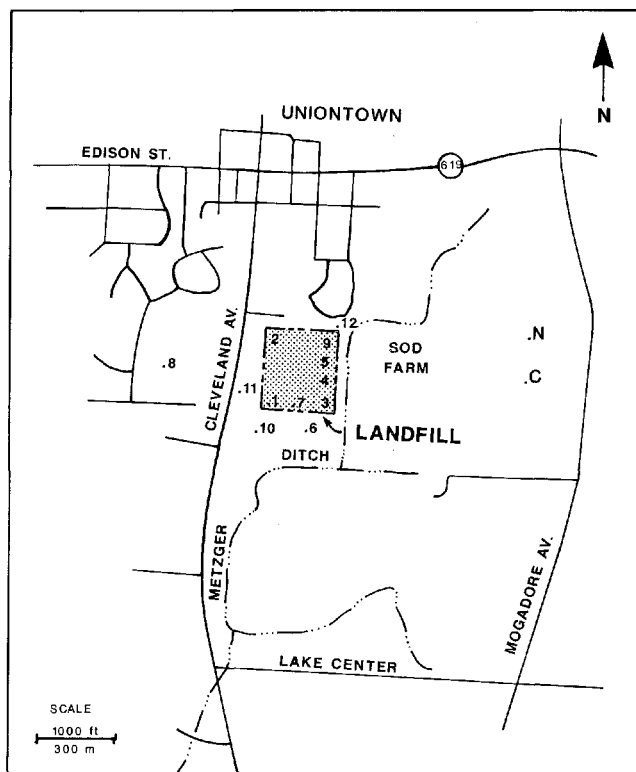
FIGURE 5. IEL ground water monitor well locations. Values in Table 2 were determined from each of these wells, with the numbering and lettering sequence as determined by C. C. Johnson & Assoc.

Water samples were obtained from monitor wells developed by C. C. Johnson and Associates. Monitor well locations 1, 3, 7, 8, 9, 10, 11 and 12 (Fig. 5) are nested, and water samples were obtained from shallow, medium and deep depths. Well depths vary and the deep wells were completed in bedrock. Samples were taken from the nest of three wells per monitor well location at shallow (S), medium (M), and deep (D) levels (Table 2). Nesting of the wells was done in an effort to test ground water quality in the upper and lower parts of the ground water found in surficial deposits and the bedrock at the site.

Measurements indicated a surprisingly low level of contamination for monitor wells within and very near a landfill developed in a sand and gravel deposit (Table 2). Bauder and Jackson believe a combination of till on the site, compaction, type of waste, cover material, and local ground water recharge areas have significantly reduced movement of contaminants off site.

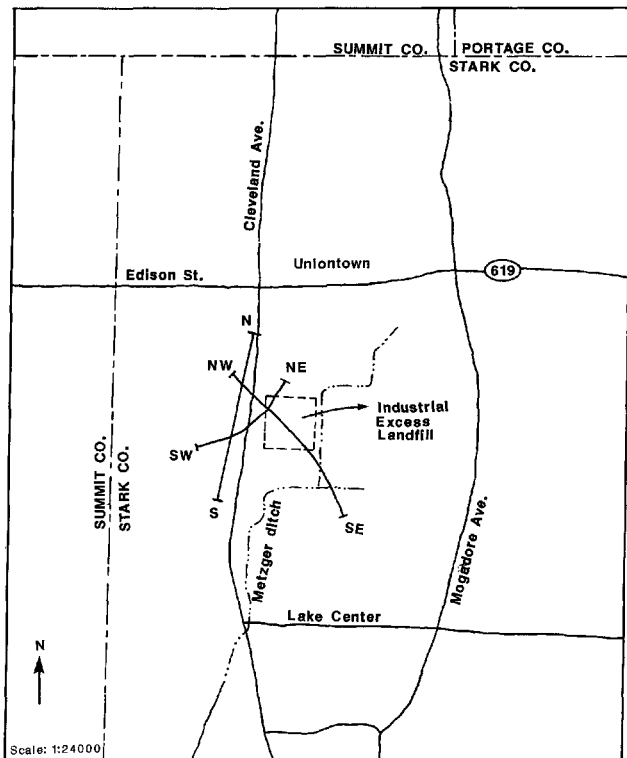
FIGURE 6. Orientation of three cross-sections through, or close by, the IEL site.

SITE CHARACTERIZATION. The Industrial Excess Landfill is on the crest and east flank of a sand and gravel ridge above a bedrock ridge. Sand and gravel were deposited first over the bedrock and/or basal till and was then covered by a layer of dense, gray basal till. Thickness of the gray basal till beneath the area of the landfill ranges from 1.4 to over 2 m thick unless it was not deposited or was eroded during the ice advance. The ice contact deposit above the lodgment till provided the bulk of the sand and gravel removed during the gravel pit operations. The landfill is on the east flank of the nearly N-S trending ridge (Fig. 6).

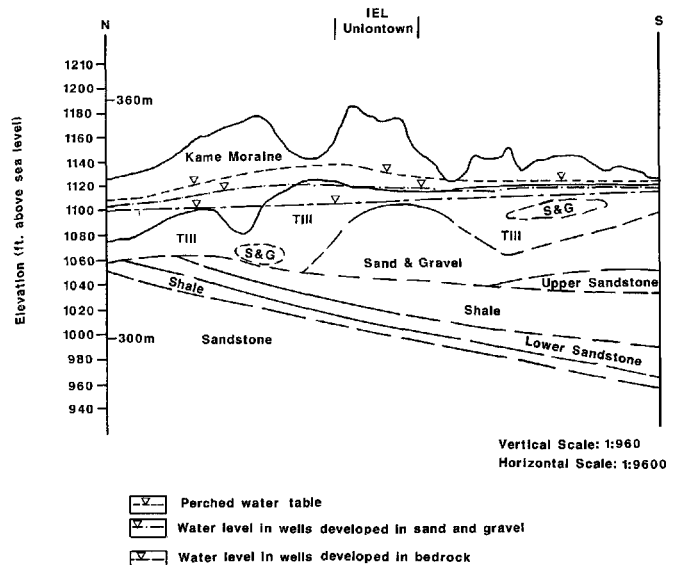
FIGURE 7. NS cross-section west of and nearly parallel to Cleveland Avenue. Refer to Fig. 6 for location relative to IEL.

The ice front "retreated" to the east to about the alignment of Cleveland Avenue and during ablation, outwash sands and gravels were deposited over the till deposit (Figs. 7, 8, 9).

The surface of the ridge is quite irregular and includes several large depressions, i.e., kettles, which occur to the north, northwest and west of the landfill site. Depressions prevent surface run-off water from escaping the area and infiltration is enhanced. Depressions act as ground water recharge areas for the shallowest water table perched over the clayey horizon(s) (Fig. 7).
