FLOOD EROSION ALONG PAINT CREEK, FAYETTE COUNTY, OHIO.

CHARLES W. NAPPER.

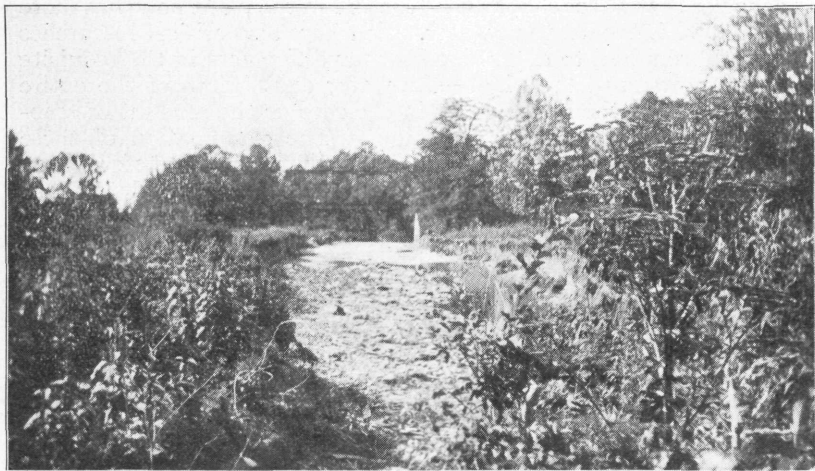
Fig. 1. General view of cut from the southern end.

At this time Paint Creek rapidly rose to its highest stage and completely filled and covered its entire flood plain. The cut made by the stream where it broke out of its accustomed channel has a mean measurement of 350 feet long, 47 feet wide, and 6 feet deep.

At the extreme southern end it terminates by narrowing into a small, shallow gulley, a foot wide. The sides are perpendicular and appear as if trimmed by hand as is shown in the photograph.

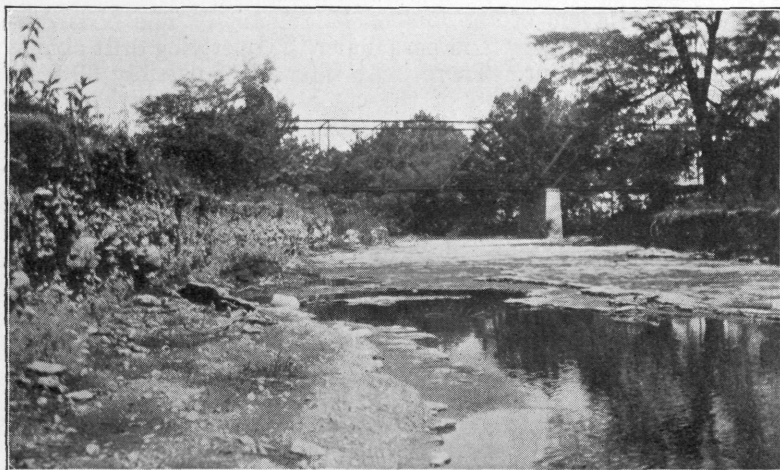
Fig. 2. Exposure of the cut wall and the dolomite.

The walls show characteristic glacial drift overlain by a thin, black soil. Beginning at the northern end for nearly half the length of the cut all the material has been removed down to the Greenfield dolomite.

On the uppermost layer of the limestone are seen splendid striations. In places the rock surface is worn smooth, polished, and clearly striated. The striae run in a northeastward direction. The exposure shows the thin, rough, undulating, uneven bedding of the upper layers of the Greenfield dolomite. The beds dip rapidly to the southwest and pass under the overlying drift about the middle of the cut. There is an interval of possibly 30 feet between the southern end of the cut and the place where the

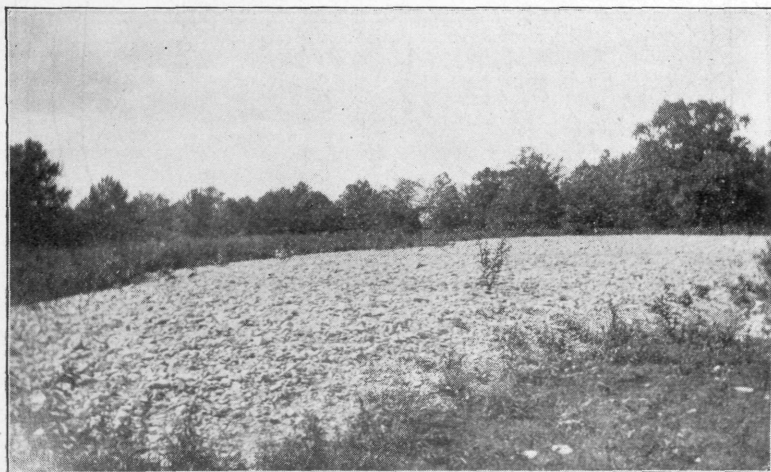
Fig. 3. Re-deposited drift in the pasture.

material was deposited. This interval is free from deposits except some very large glacial boulders. Some variation in the velocity of the stream held the material in suspension only to drop and spread it out lower down. The re-deposited drift material is spread over a heavily sodded pasture to a thickness of three feet, covering a space 350 feet long and 100 feet wide. Comparing

measurements it will be seen that the deposit is the same length, about twice the width, and one-half the depth of the cut. Therefore this material will fit in the excavation already described.

The deposit has been washed clean and stands out in very strong contrast with the sod on which it has been laid. An examination of the material shows igneous, metamorphic, and sedimentary rocks mixed in hopeless confusion.

The top layers of the Greenfield dolomite were loose and shattered in many places. The force of the water tore away slabs of this rock and carried them along with its load of drift. Hence in the deposit finely glaciated pieces are to be found.

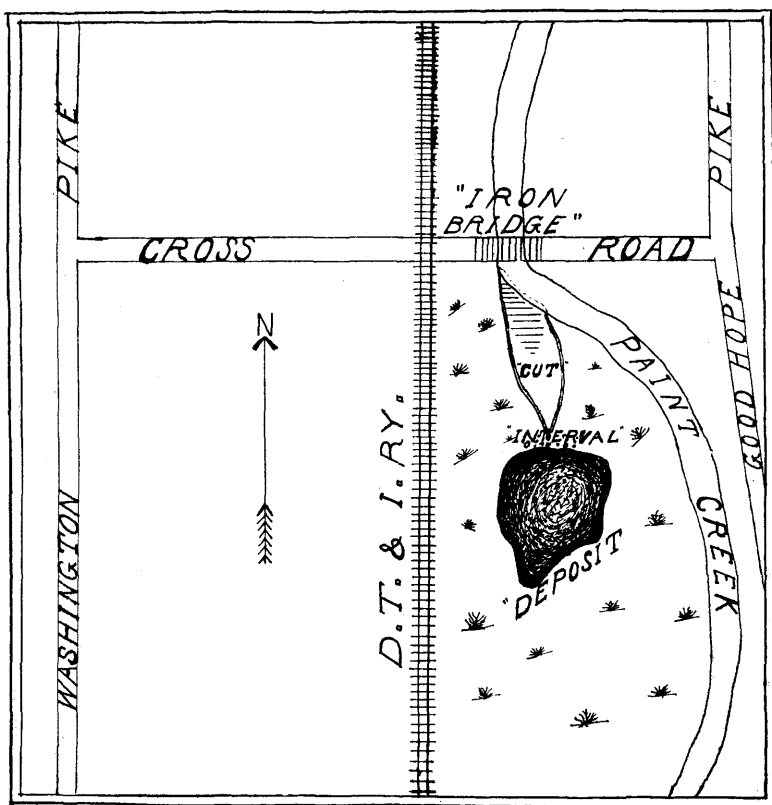
Fig. 4. Map of the Paint Creek cut.

From the sketch it can be seen that the deposit extends toward the southwest. This results from a gulley running beside the railroad track which served to maintain the water volume and velocity.
