# The Effects of Year-Round Irrigation on Landscape Plant Quality and Health in Ohio

HEATH CALDWELL, KAREN MANCL<sup>1</sup>, and MARTIN F. QUIGLEY, Malcolm Pirnie, Inc., Columbus, OH; Food, Agricultural and Biological Engineering, The Ohio State University, Columbus, OH; and UCF Arboretum, University of Central Florida, Orlando, FL

OHIO J SCI 107 (4): 76-81, 2007

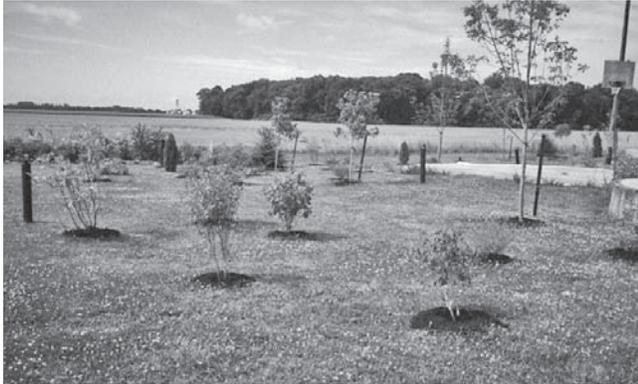
FIGURE 1. Example plants in year-round irrigated plot displaying mid-summer leaf color and vigor

Observations for nearly all the plants showed good vigor in the year-round irrigated plot. The only exceptions were the two evergreen species. The *Tsuga Canadensis* showed low leaf numbers and the *Thuja occidentalis* had yellow leaves. The evergreens in the summer irrigated plot showed good vigor. In the non-irrigated plot eight plants died and eight showed poor vigor. Observations were recorded with photographs such as those presented in Figs. 1, 2 and 3.

Nearly all the plant showed good vigor in the year-round irrigated plot. The only exceptions were the two evergreen species. The *Tsuga Canadensis* showed low leaf numbers and the *Thuja occidentalis* had yellow leaves. This compared to the non-irrigated plot where eight plants died and eight showed poor vigor. The evergreens in the summer irrigated plot showed good vigor, suggesting that winter irrigation is detrimental to hemlock and arborvitae.

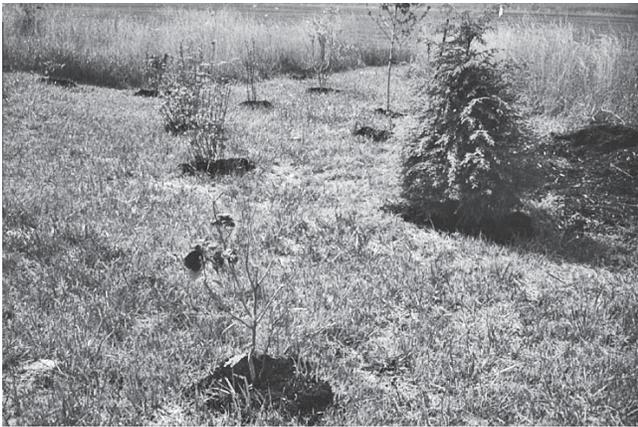
FIGURE 2. Examples of plants in April through October irrigated plot displaying mid-summer leaf growth and vigor. Note the healthy hemlock evergreen tree.

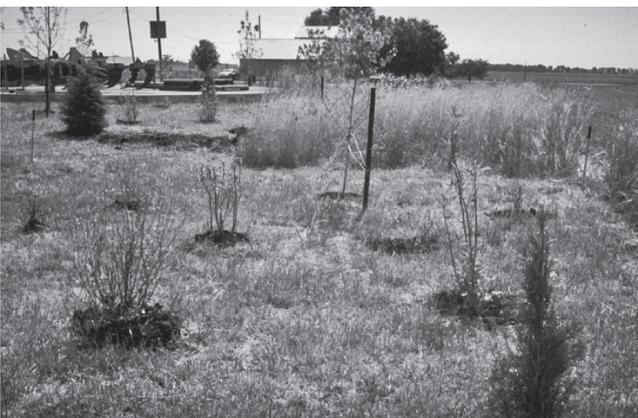
FIGURE 3. Examples of plants in control plot (no irrigation) displaying extremely poor vigor and mortality.

and *Mtrica pennsylvanica*, lacked vigor with deaths of both specimens. Two other species, *Diervilla sessilifolia* and *Salix purpurea* had deaths of one of two specimens. Out of the remaining 19 specimens, *Aronia arborea*, *Ilex verticulata*, *Rhus aromatica*, *Thuja occidentalis*, *Tsuga canadensis*, and *Viburnum dentatum* had an average decrease in size. Animal grazing damage was observed in both specimens of *Thuja occidentalis*, and *Viburnum dentatum* and one specimen of *Aronia arborea*. The remaining five species displayed an average growth of 2.5 cm (one inch). Two evergreen species (*Tsuga canadensis* and *Thuja occidentalis*) displayed poor leaf quality, health, and vigor. *Ilex verticillata* and *Rhus aromatica* were observed to have poor leaf quality, health, and vigor in a single specimen. Of the 29 specimens in the non-irrigated plot, eight were dead and eight others displayed poor vigor leading to imminent death.

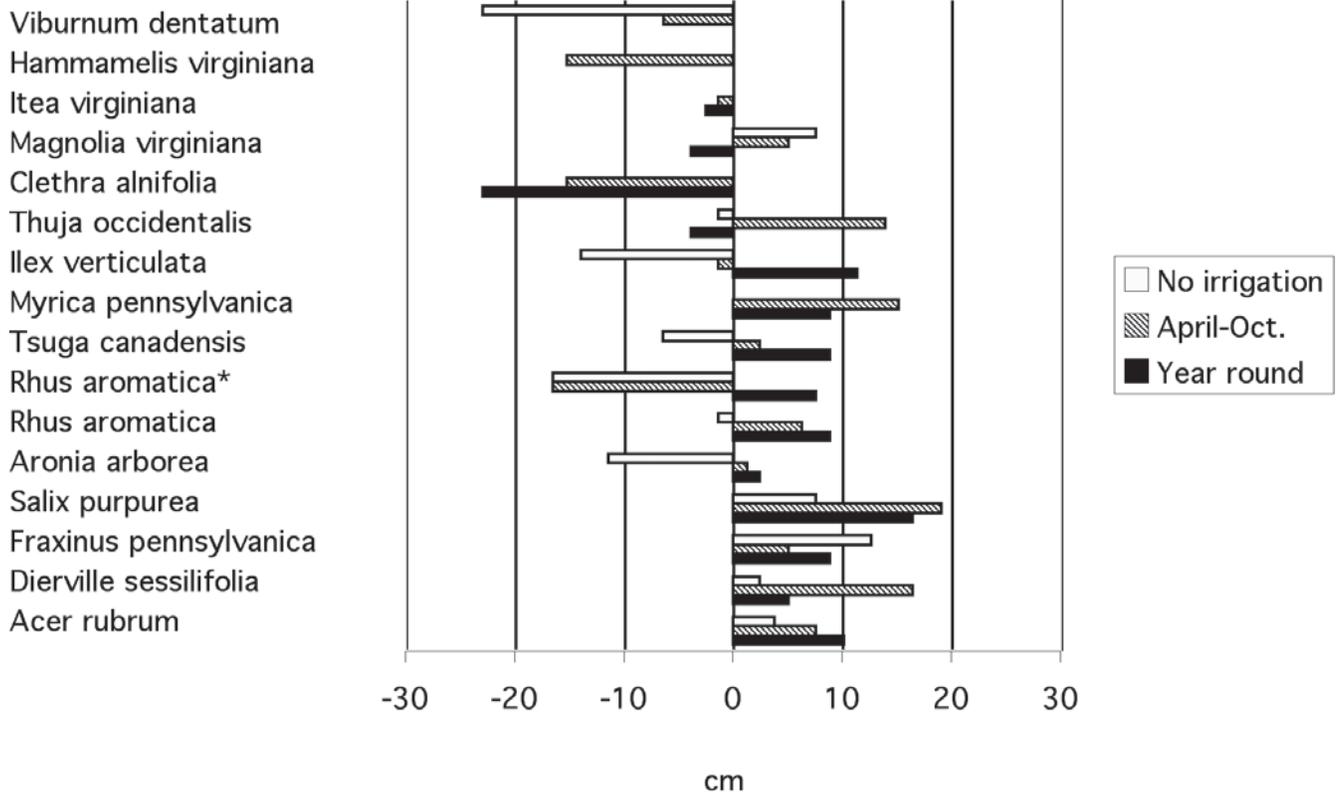
\* horizontal growth of species.

FIGURE 4. Comparative one-year vertical growth (cm) of ornamental and native plant species subject to three irrigation regimes. Negative growth the result of stem death or animal grazing. Values are the average growth of two plants of each species per irrigation treatment.

The growth differences between the two irrigated plots and the non-irrigated plot may also be due to the evaporative cooling effects on the species that were irrigated. Protection from summer heat was provided through irrigation, which acted to decrease the plant temperature. Any heat required to evaporate water from the plant was heat to which the plant was not exposed. Through the combined effects of irrigation and evaporative cooling average species growth, in the irrigated plots, was enhanced (Fig. 4).
